Manhole Inspection Summary

Manhole # S19I__046MH

Insp Date: **3/4/08 11:45 AM**

Location Address: **32 boyd st**

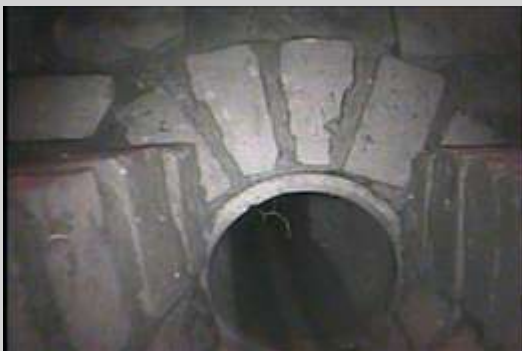
3 O'Clock Inflow

6 in. Circular Gravity Sewer
Pipe In @ 3 O'Clock

Pipe Height: **6** (in.) Rod and Bar (Angled)
Pipe Material: **Clay** ☐ Pipe Lined
Invert Depth: **8.16** (ft.) Flow Characteristics: **Slow**
Deposits: ☒ None ☐ Mud ☐ Sludge ☐ **Debris** ☐ Grease
Silt Depth: **0** (in.) Deposits Extent:
Infiltration: **None** Pipe Seal Cond: **Sound**

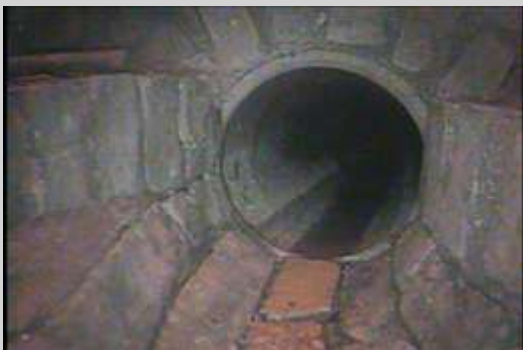
9 O'Clock Inflow

8 in. Circular Gravity Sewer
Pipe In @ 9 O'Clock

Pipe Height: **8.4** (in.) Rod and Bar (Angled)
Pipe Material: **Clay** ☐ Pipe Lined
Invert Depth: **8.24** (ft.) Flow Characteristics: **Slow**
Deposits: ☒ **None** ☐ Mud ☐ Sludge ☐ Debris ☐ Grease
Silt Depth: **0** (in.) Deposits Extent:
Infiltration: **None** Pipe Seal Cond: **Sound**
